## Environmental Baseline Survey

# Albany West

Caribbean Coastal Services Ltd.

08 May 2020

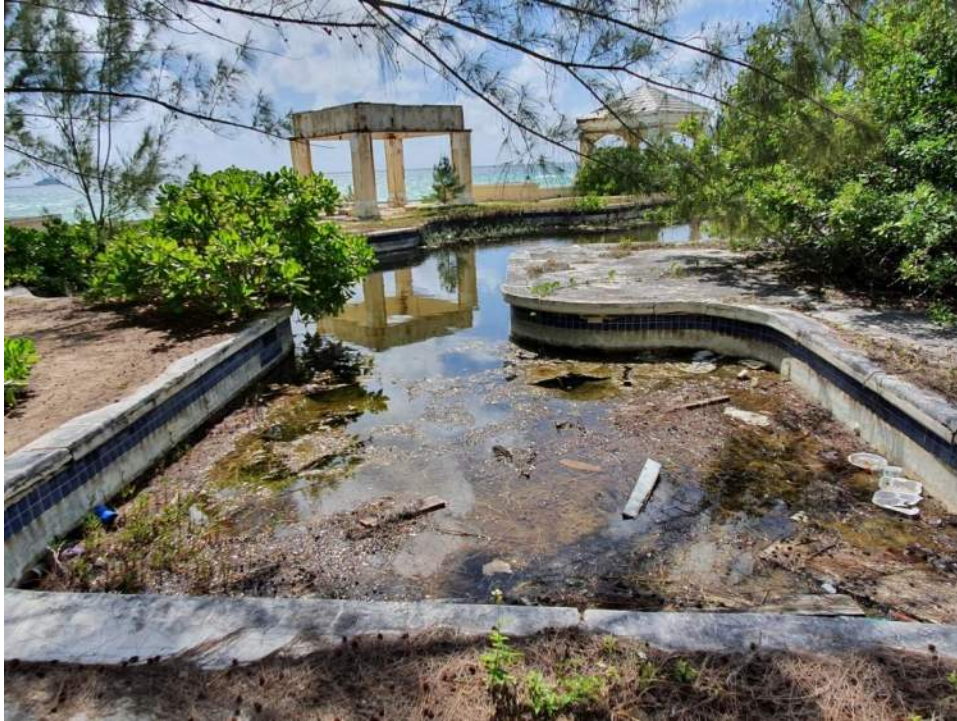
Figure 10. Pool with stagnant water at the former South Ocean Resort

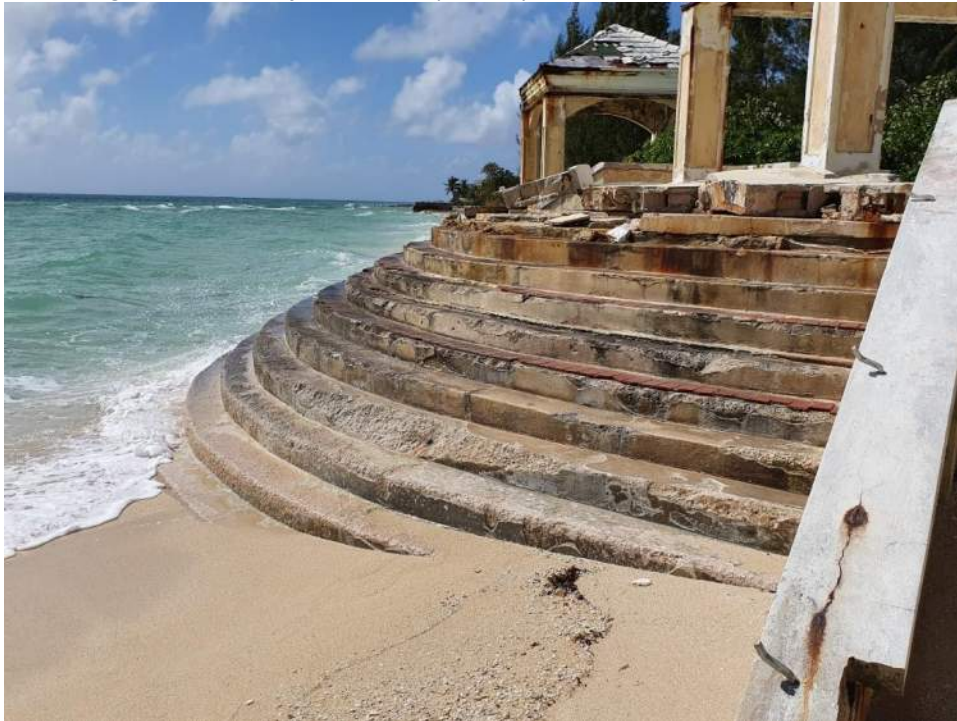
*Figure 16. Coastal infrastructure impacted by coastal erosion and sedimentation*

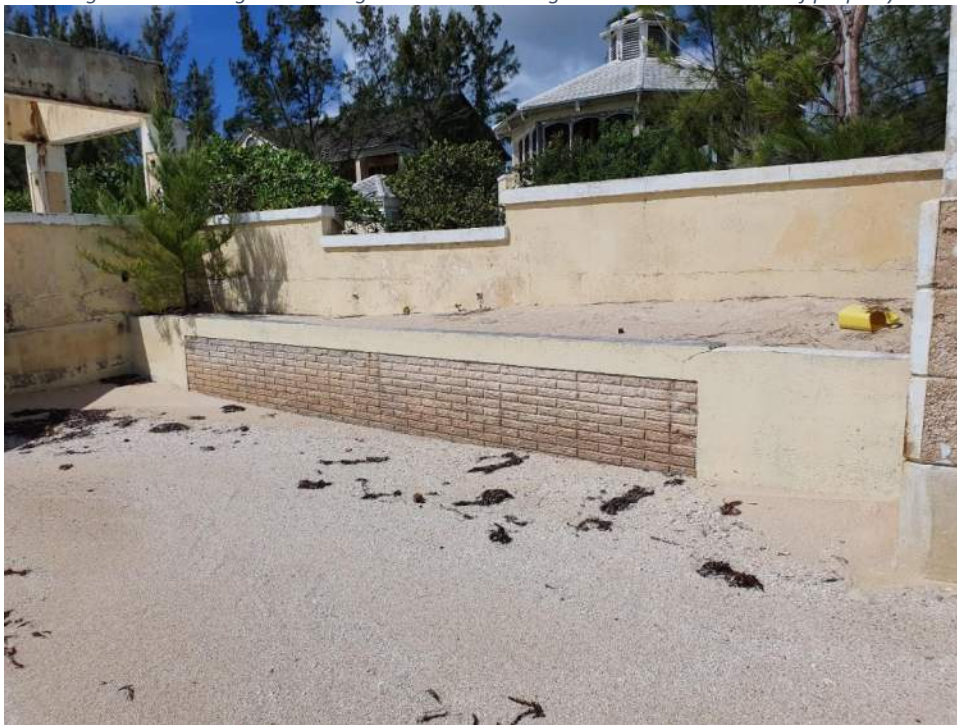
*Figure 17. Existing seawall in good condition along the southern shoreline of property*

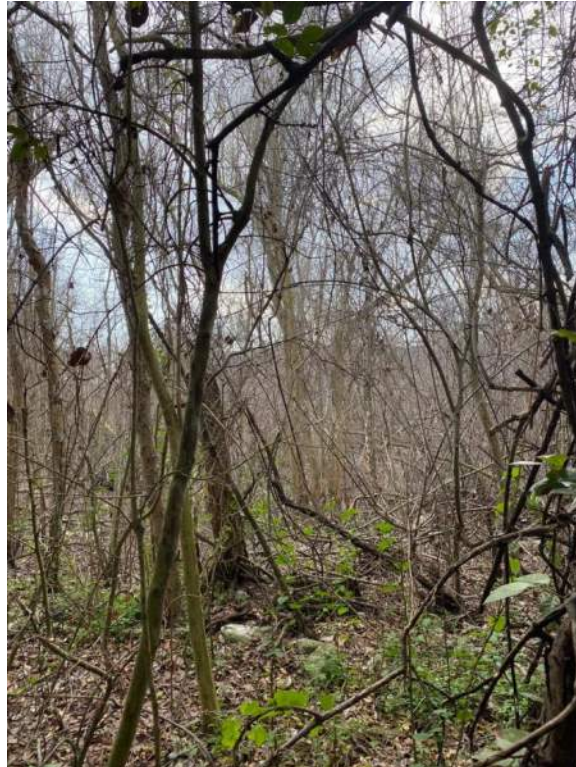
Figure 25. Disturbed forest exhibiting dieback and defoliation

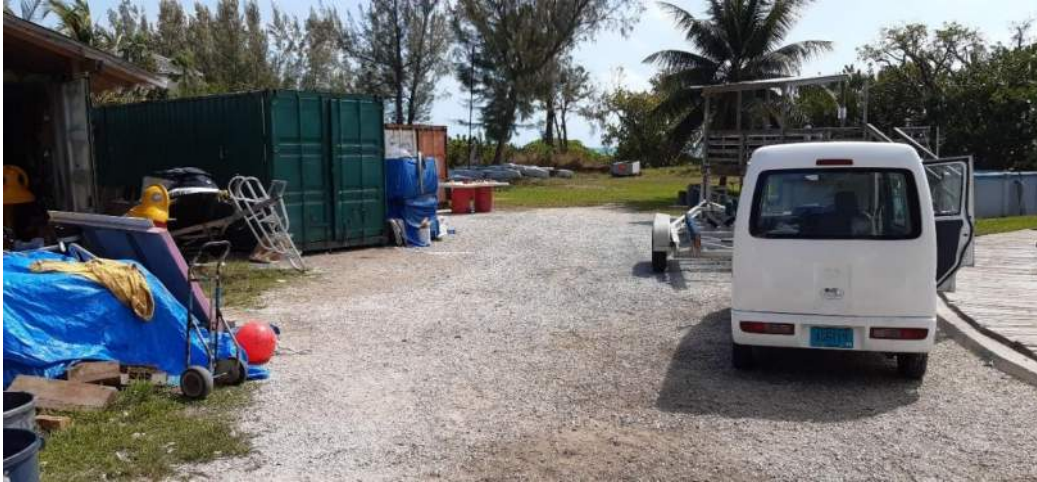
Figure 36. Stuart Cove's boat yard and maintenance area

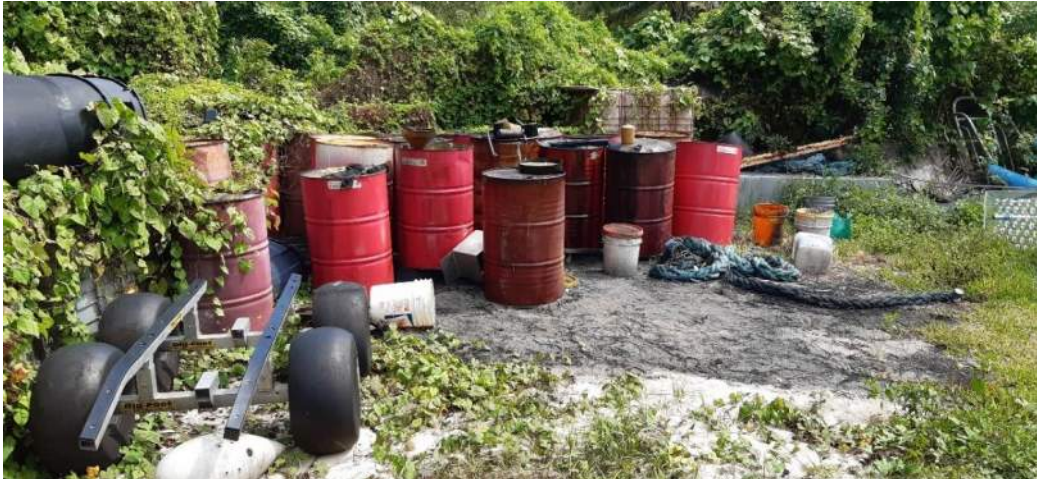
Item	Location	Notes
<b>Oil Drums</b>	Stuart Cove's Maintenance Area	55 gallon metal barrels containing possible petroleum products stored outdoors. Visible staining on ground beneath and surrounding barrels. No visible secondary containment area.
<b>Boat Yard</b>	Stuart Cove's Maintenance Area	Visible staining on ground in areas used for boat repair and maintenance. Potential sources include fuels, oils solvents, antifouling paint, degreasers, acidic/alkaline solutions and other by products e.g. heavy metals
<b>Septic Tank</b>	Stuart Cove's Maintenance Area	Proximity to marina basin increases potential for soak-away products entering marine environment.

Figure 37. Storage of suspected petroleum products in metal drums, visible staining on ground surrounding barrels.

The maintenance and storage area of Stuart Cove's had visible staining of the ground from suspected petroleum products, and is also suspected of discharges into the ground from boat repair and maintenance chemicals, solvents and other hazardous materials. The hydrocarbons from the maintenance area were remediated by Engineers and Consultants Ltd (ECL), and a secondary containment area built for oil storage in the maintenance area. Recovered contaminated soil was disposed of at New Providence Ecological Park Ltd. (NPEPL). During demolition of the Stuart Cove's facility it is recommended that if hydrocarbon stained soil is observed during excavation in the maintenance areas, that further testing and remediation of potentially contaminated soil and ground water be conducted prior to construction in accordance with best practices and the DEHS/BEST Commission. Full details of the investigative and remediation procedures will be outlined in the project's EMP.

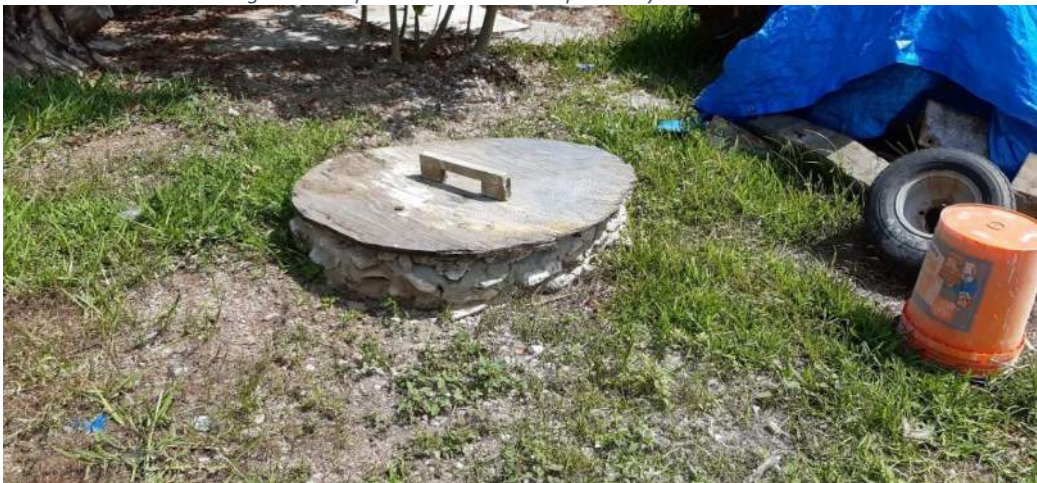
Figure 38. Septic tank within close proximity to marina basin

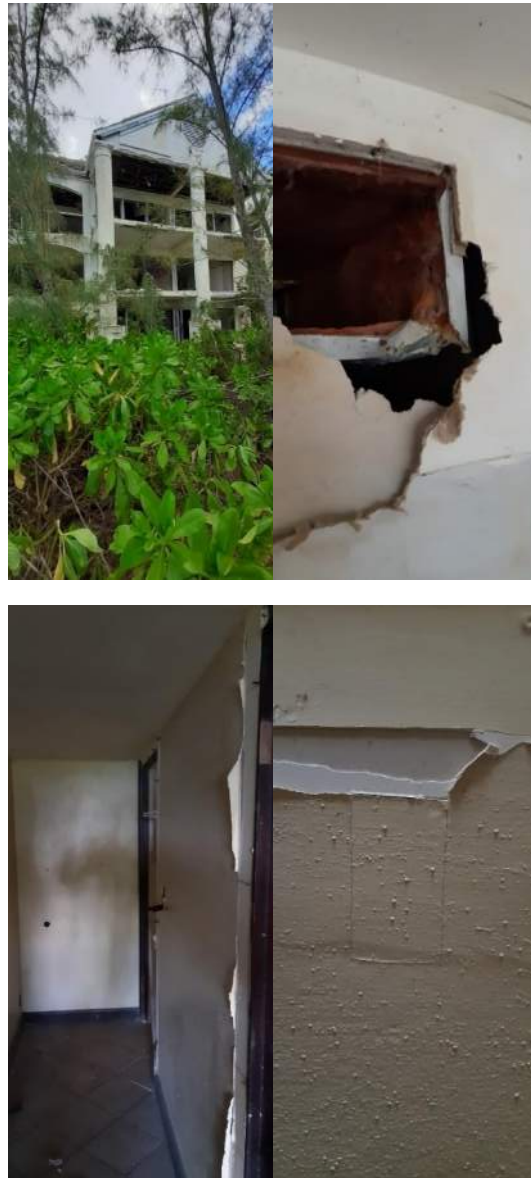
Figure 39(a-d). Sampling location Great House 6, samples taken from interior insulation and drywall (ACM), and interior wall paint (lead).

The absence of lead and asbestos within Phase 1A demolition material will not require the recommended abatement and disposal of these hazardous materials prior to demolition of the structure. Demolition waste from the project site will be disposed of according to best practices and regulations put forth by The Department of Environmental Health Services, BEST Commission and the Government of The Bahamas.

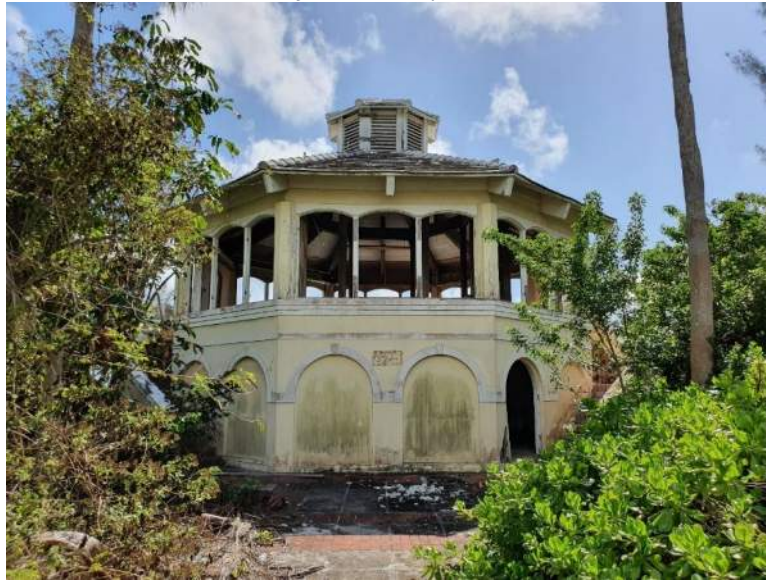
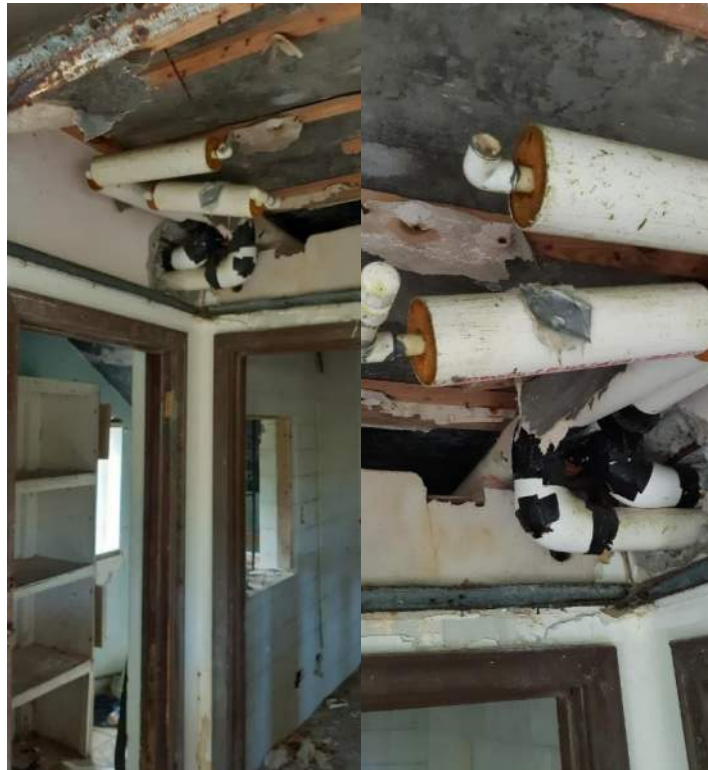
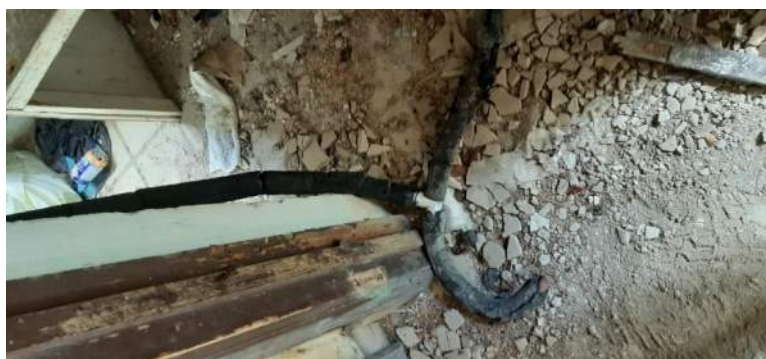
Figure 40(a-d). Sample location Pool Kitchen, ACM samples collected from pipe insulation and drywall, lead samples taken from exterior paint

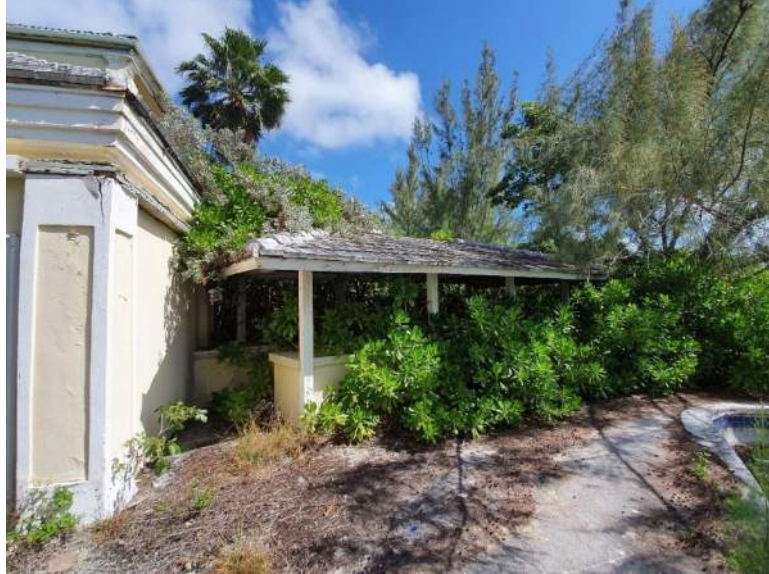
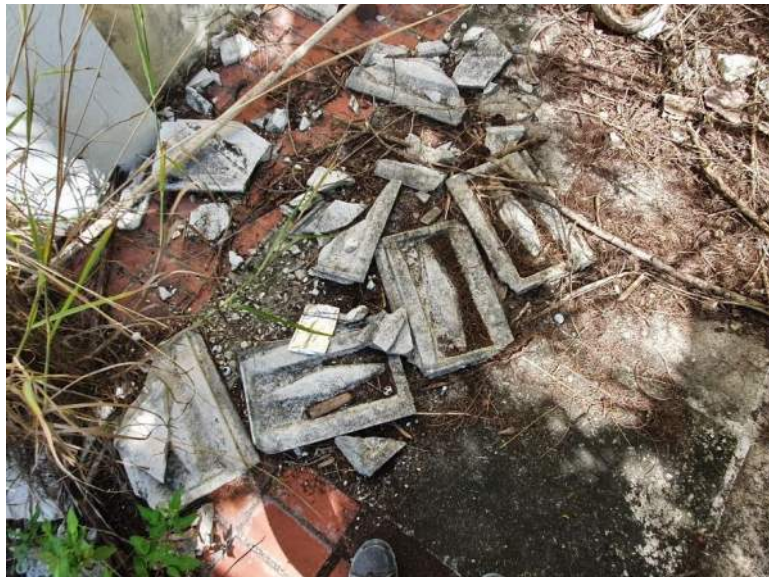
Figure 41. Sample location Pool Bar, ACM samples collected from concrete roof tiles

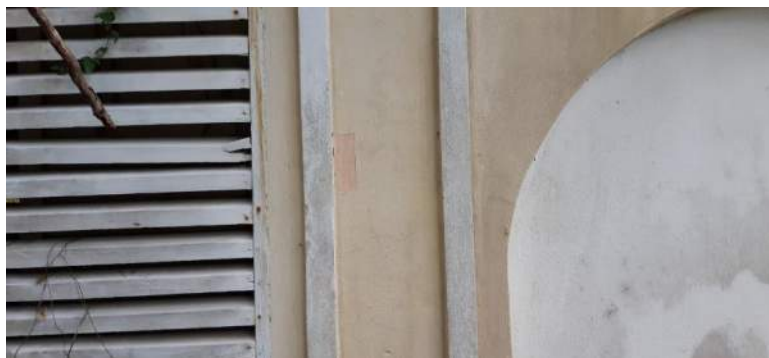
Figure 42. Sample location Pump House, lead sample taken from exterior paint

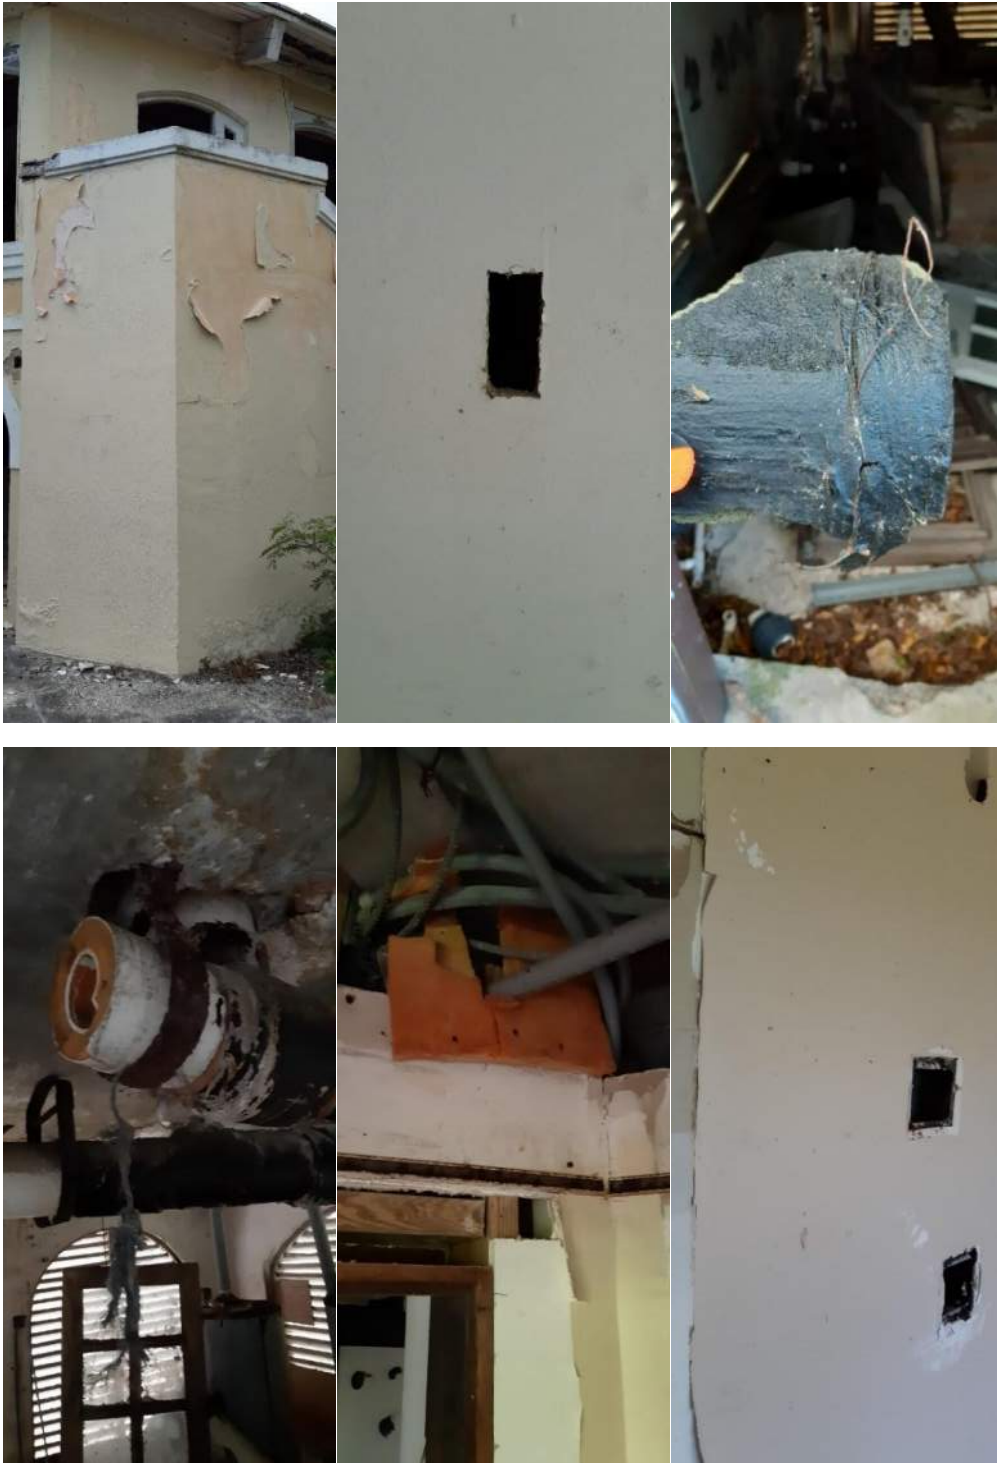
Figure 43 (a-f). Lead sample exterior Pool Kitchen; ACM sample interior Pool Kitchen; ACM sample pipe insulation Pump House; ACM sample pipe insulation Pump House; ACM sample AC insulation Great House 2; ACM and lead sample interior Great House 2.

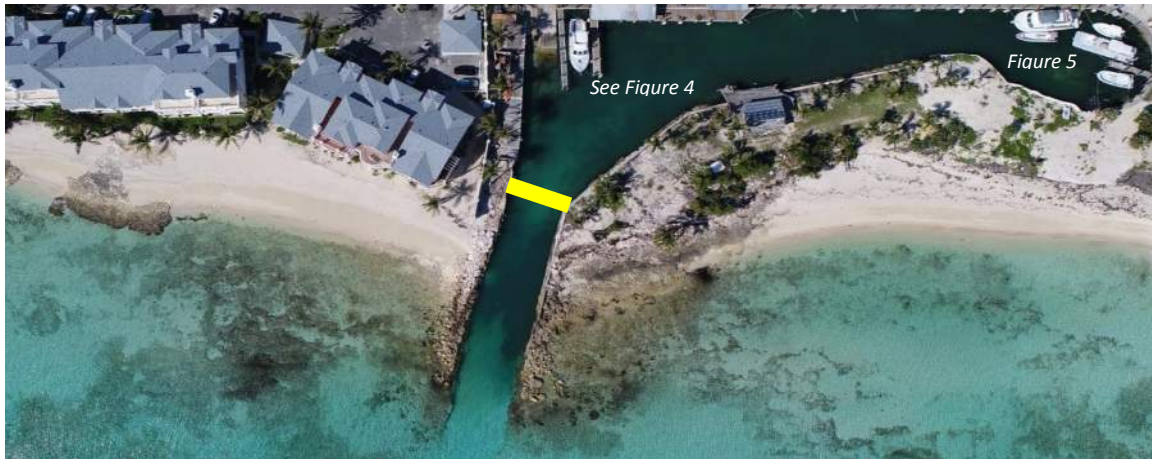
Figure 44<sup>1</sup> Aerial image of L-shaped marina with one opening. The yellow line shows the land reclamation limit.

The reclamation of the marina basin will produce large amounts of turbidity in the immediate basin area. A turbidity screen will be utilized at the marina channel entrance to prevent sediment from impacting near shore areas adjacent to the project site. Turbidity monitoring is recommended prior to commencement of reclamation and periodically during this phase of the project.

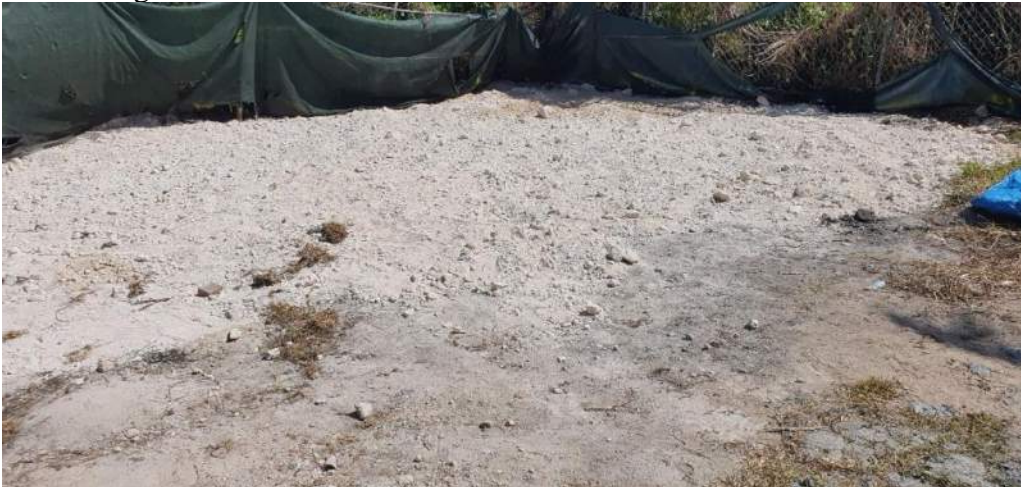
The above shows the area where 55 gallon drums of used oil were previously stored. The contaminated soil was removed and delivered to the NPEPL for remediation and safe disposal and fresh fill material placed in the void.

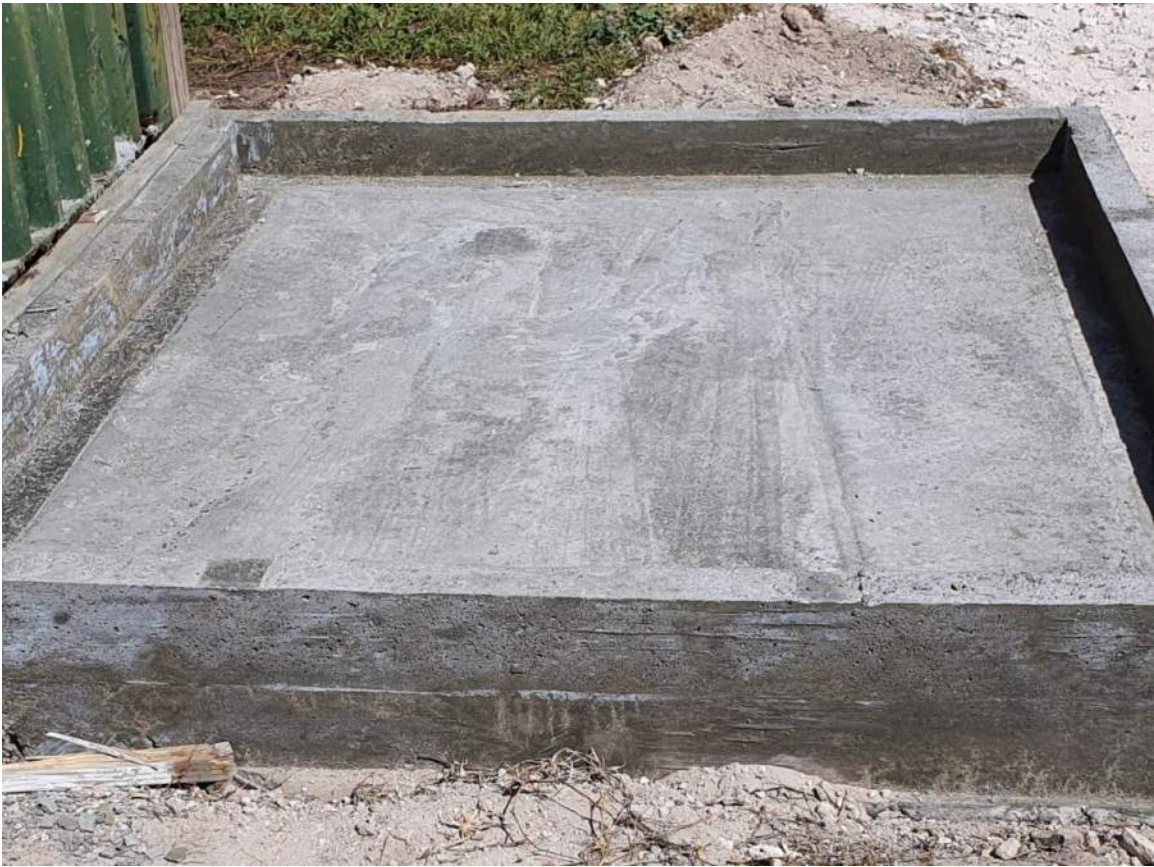
The above displays the plinth with lip that has been prepared for the new used oil and new oil area. A tote (275 gallons) will be placed here to receive used oils. Also a cradle (shown below) with new oil will be placed on this plinth.

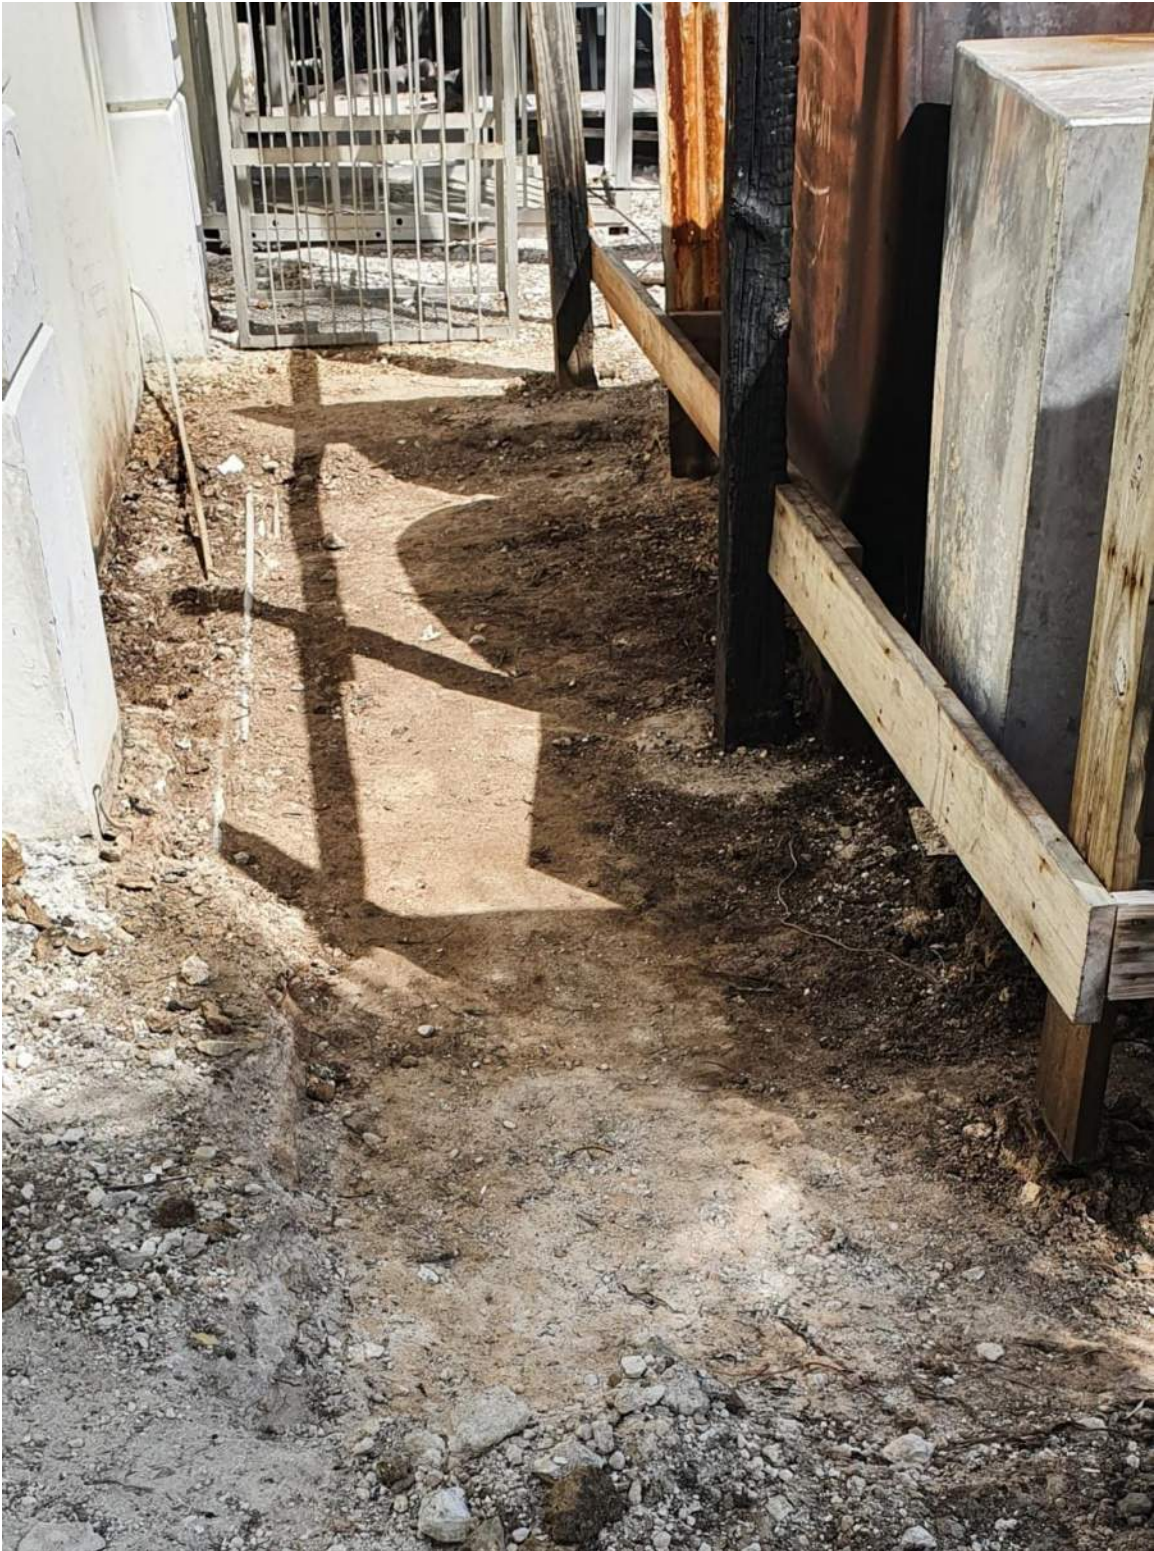
The above shows the fuel storage area where some pcs has already been removed and delivered to NPEPL for remediation. The remainder will be removed and delivered to NPEPL when the tanks are removed and relocated to Coral Harbour. They anticipate the relocation to occur either Thursday or Friday depending on the crane availability.
